MONTANA DEPARTMENT OF TRANSPORTATION STREAM MITIGATION MONITORING REPORT

*Spring Creek
Flathead County, Montana*

*Project Completed: 2010
Monitoring Report #4: December, 2016*

MDT Project Number: NH-MT 5-3(59) 109
Control Number: 2038

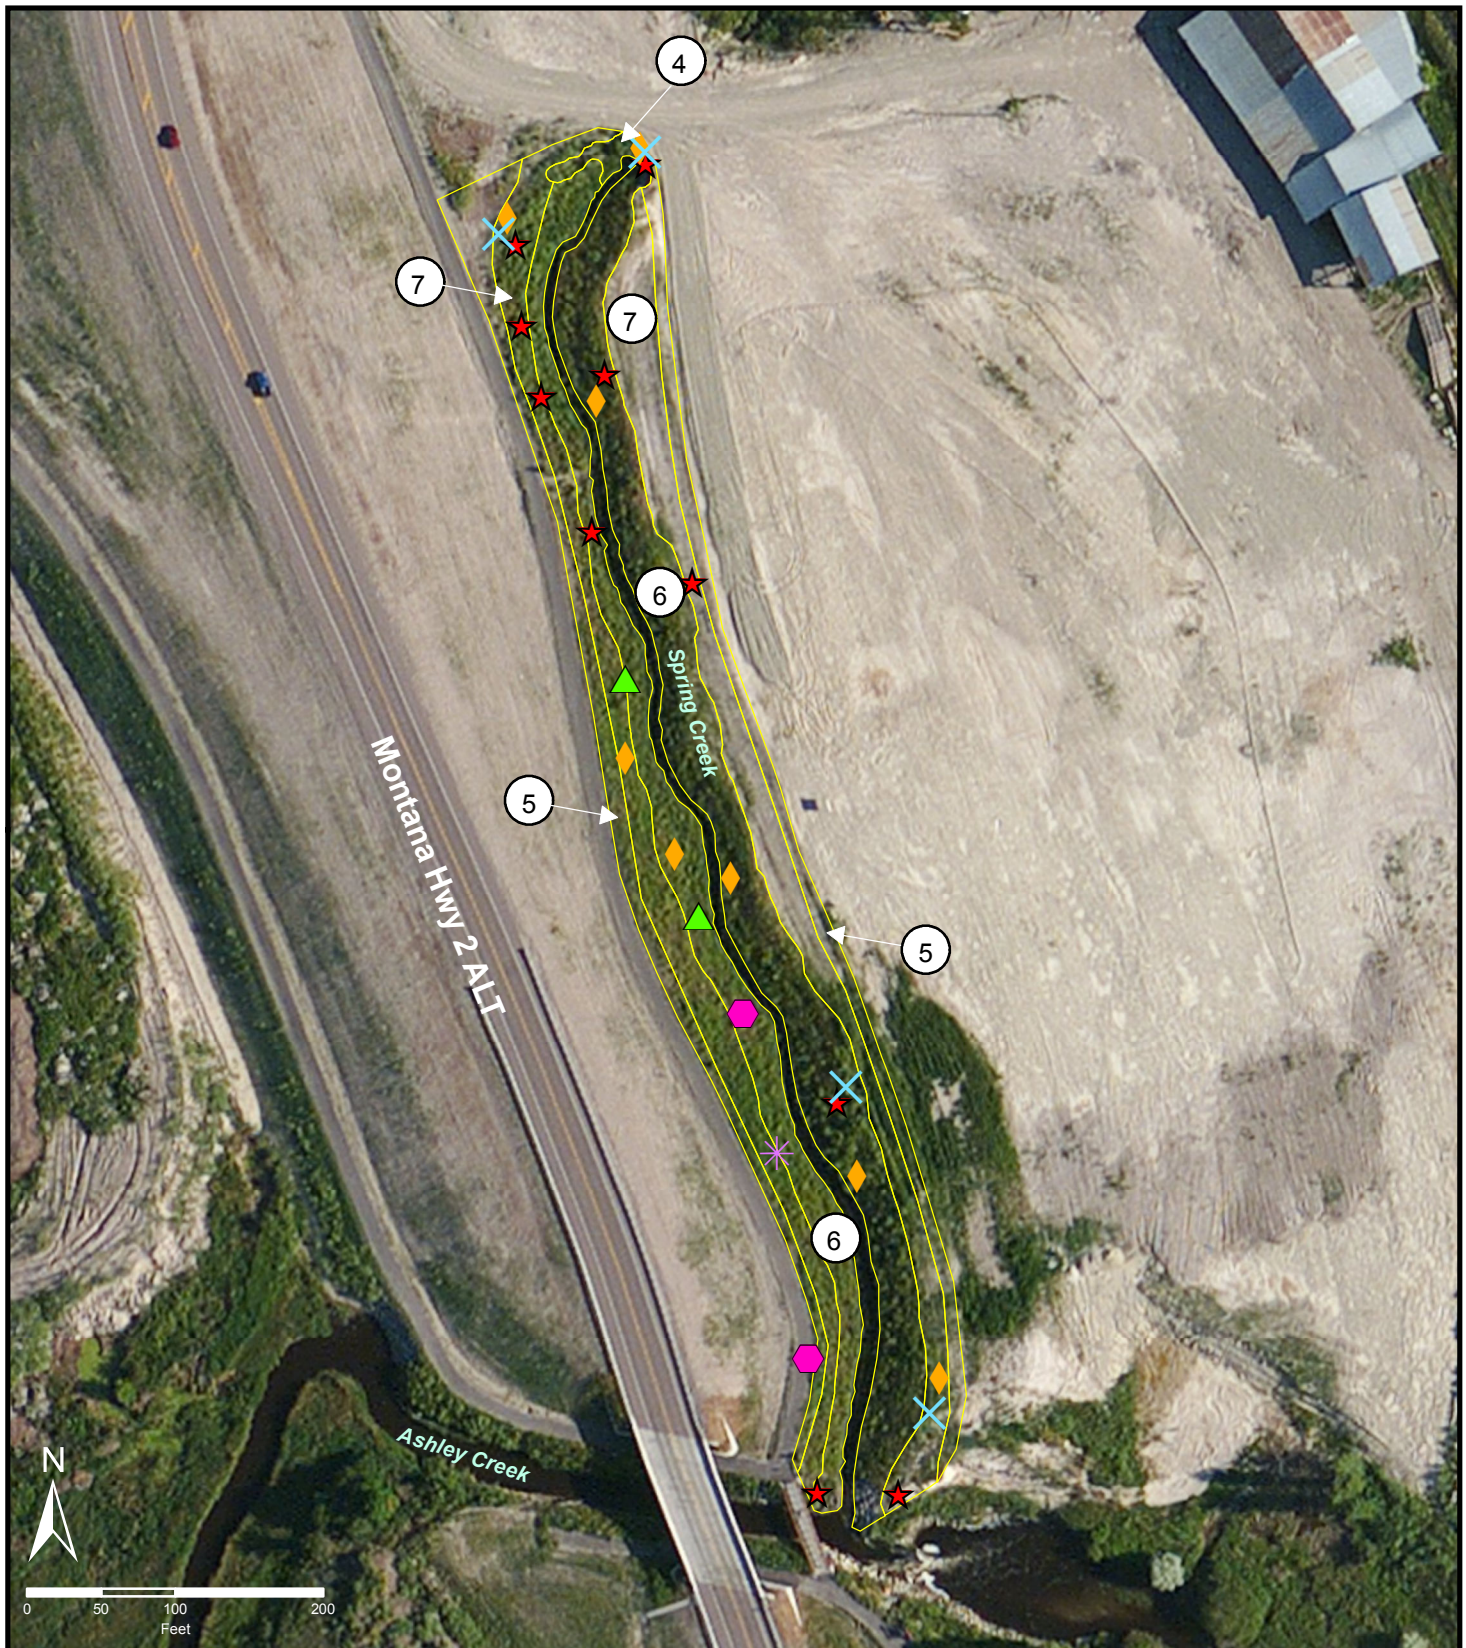
Eroding Bank	Spring Creek - 2016 Monitoring Features
			Figure 3
			Date: 10/13/2016
			Spring_features2016.mxd

In 2015, one 30-foot eroding bank was identified within the project reach (Figure 3, Appendix A). Inspection of this bank in 2016 revealed no additional bank retreat or increase in eroding bank length over the past year (See Additional Photo 2 in Appendix C). Erosion at this location is most likely due to degradation of coir logs used to construct the channel. The bank occurs approximately 30 feet downstream of a beaver dam, which may cause accelerated velocities during storm events just downstream. The adjacent riparian corridor is well vegetated with reed canary grass, Maximilian sunflower, and Canada thistle; however, little floodplain exists along the west side of the channel at this location to disperse energy during high flows. Based on the lack of continued erosion and a densely vegetated riparian zone adjacent to the bank, erosion severity along this bank segment is considered low.
